HARBOR HEALTH STUDY

Harbor Health Study: 2021

*The Harbor Health Study is a collaborative effort between **Harbor Watch, Copps Island Oysters, and East Norwalk Blue** to collect data on the ecosystem health of local embayments.*

Demersal fish in Norwalk Harbor and water quality in Stamford Harbor, Five Mile River Harbor, Norwalk Harbor, Saugatuck Harbor, Bridgeport Harbor (Johnsons Creek and Lewis Gut), Housatonic River, and New Haven Harbor (Quinnipiac River)

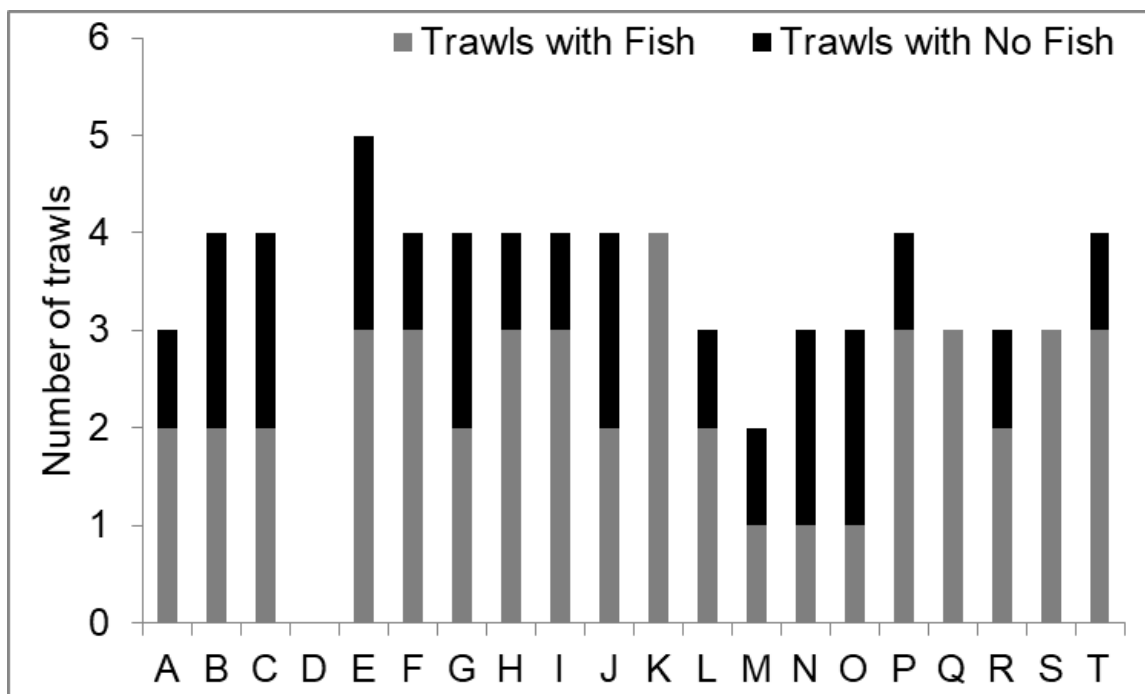
Figure 1.3. Number of trawls with fish or without fish in each “box” in Norwalk Harbor, May through October 2021. No trawling was conducted in box D due to a cable crossing.

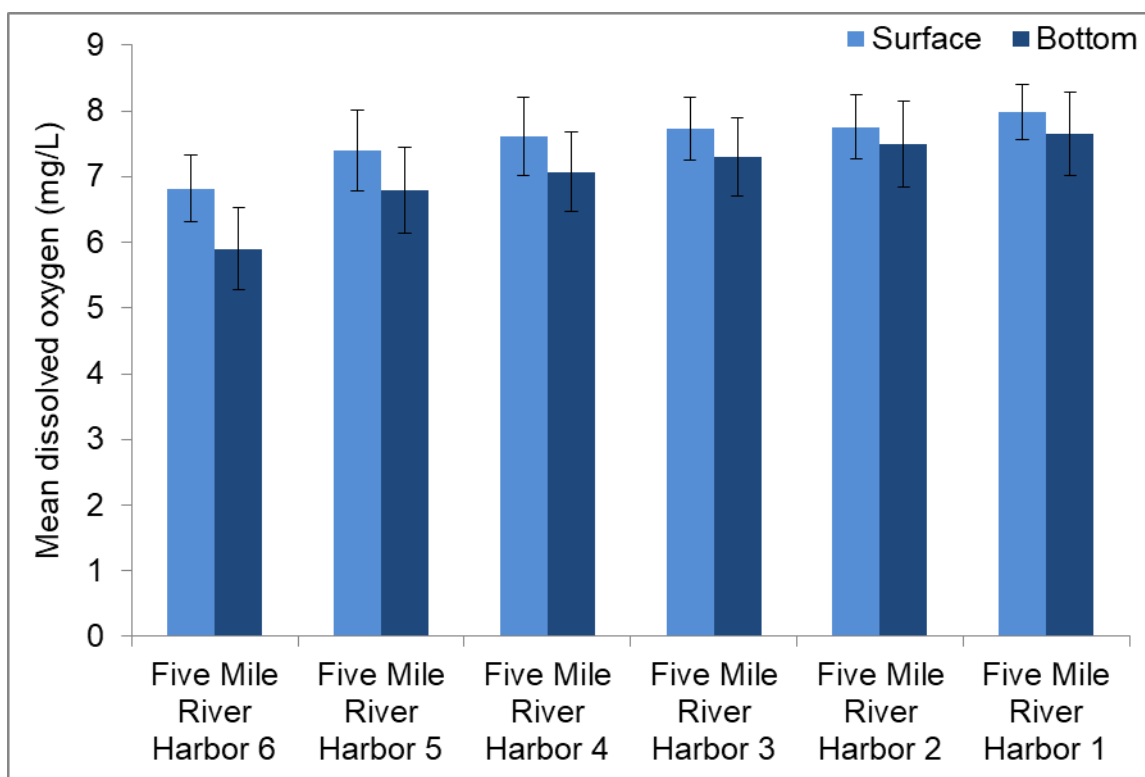
Figure 2.B.2. Mean dissolved oxygen concentrations at the surface and bottom at each sampling station in Five Mile River Harbor in 2021. Error bars represent standard error.

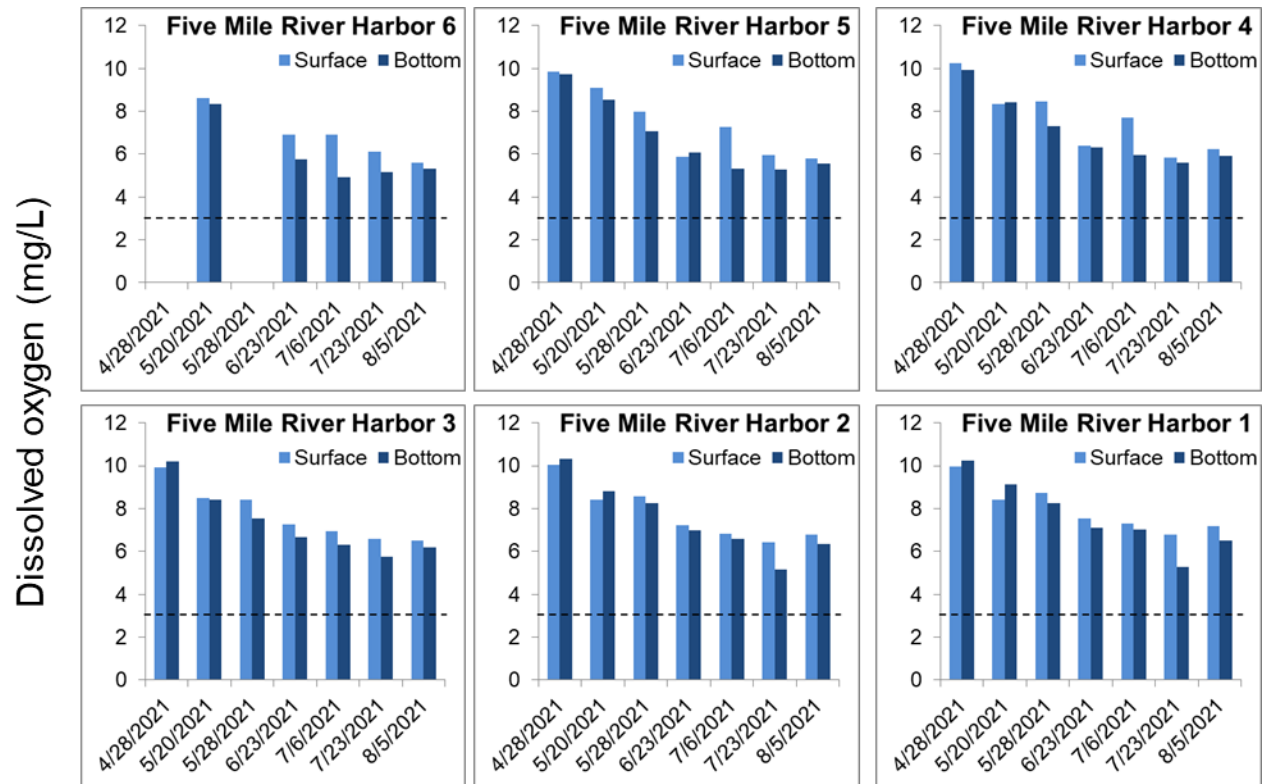
Figure 2.B.3. Surface and bottom dissolved oxygen values at each Five Mile River Harbor sampling station on each monitoring date during the 2021 season. The dotted line represents hypoxic conditions (3 mg/L). Station Five Mile River Harbor 6 was not completed on 4/28/21 and 5/28/21 due to inaccessibility. Please note x-axis is not to scale.

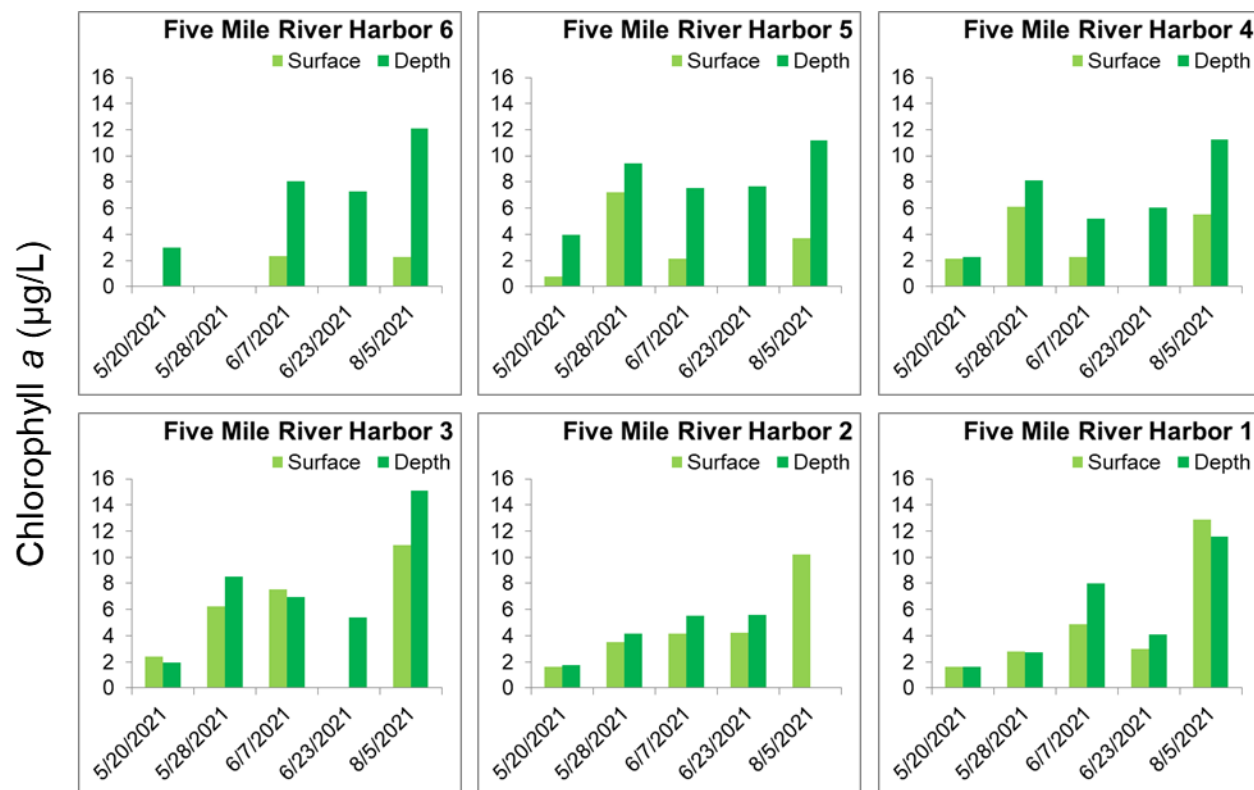
Figure 2.B.4. Surface and depth chlorophyll *a* values in Five Mile River Harbor in 2021. Light green bars represent surface samples and dark green bars represent samples collected at depth, which was either at 2m below the surface or the bottom if the depth during sampling was < 2m. Please note x-axis is not to scale. Additionally, on 6/23/21 samples were mislabeled resulting in no data available for surface concentrations at stations Five Mile River Harbor 6, Five Mile River Harbor 5, Five Mile River Harbor 4, and Five Mile River Harbor 3.

Chlorophyll *a* samples were taken on 5 of the 7 sampling days in Five Mile River Harbor. Samples were not taken at Five Mile River Harbor 6 on 5/28/21. In prior years, the harbor was categorized in the medium eutrophic range. In 2020, the harbor was classified as in the highly eutrophic range, largely driven by one outlier in September (Crobsy et al., 2018b, 2019b). 2021 mean surface chlorophyll *a* classified the harbor in the low eutrophic range (Table 2.1). It should be noted that frequently throughout sampling, chlorophyll *a* concentrations from the depth sample were higher than those at the surface.

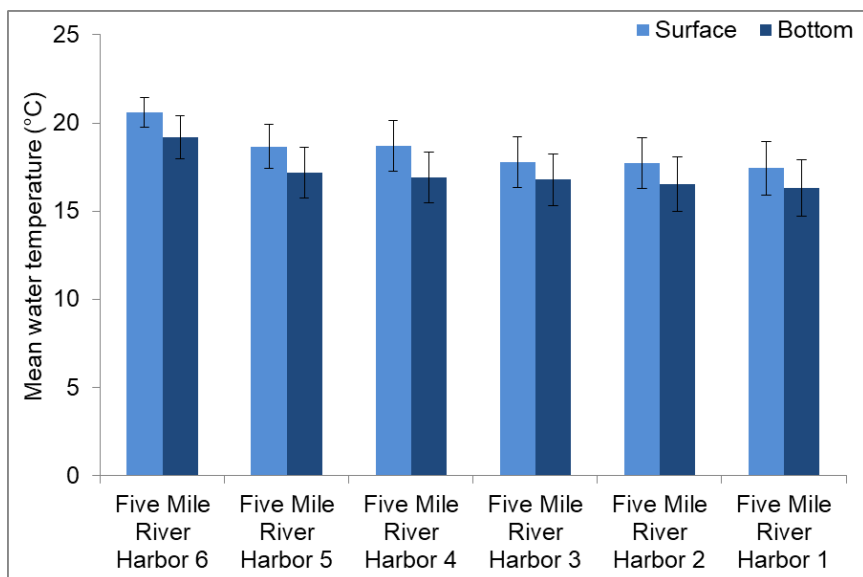
Figure 2.B.7. Mean water temperature at the surface and bottom at each sampling station in Five Mile River Harbor in 2021. Error bars represent standard error.

Mean surface and bottom water temperature in Five Mile River Harbor were similar throughout the harbor (Figure 2.B.7). Lower salinity observed at the surface in the landward end of the estuary reflects the impact of Five Mile River input from the north and Indian Creek input upstream of Five Mile Harbor 5, where the harbor is less well mixed (Figure 2.B.1, Figure 2.B.8). It is important to note that Five Mile River Harbor 6 could only be tested at high tide, which likely resulted in smaller ranges between surface and bottom salinity observations.

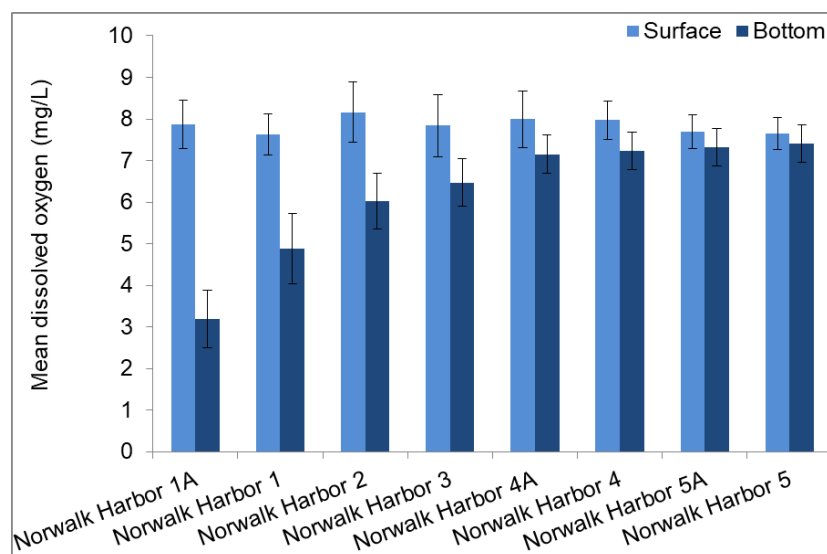
Figure 2.C.3. Mean dissolved oxygen concentrations at the surface and bottom at each sampling station in Norwalk Harbor during 2021. Error bars represent standard error.

Wide ranges in dissolved oxygen concentrations at the surface and bottom were observed in most of the upstream sampling locations (Figure 2.C.3, Figure 2.C.4). At the sampling locations further seaward, the differences in dissolved oxygen concentrations were smaller, presumably from the larger width of the harbor and increased mixing reducing stratification. The upper 3 stations, Norwalk Harbor 1A, Norwalk Harbor 1, and Norwalk Harbor 2, likely had a highly stratified water column throughout the season based on limited mixing time with the flow of fresh water entering the harbor from the Norwalk River (Figure 2.C.3, Figure 2.C.9). Station Norwalk Harbor 1A was the most impaired water in the harbor for dissolved oxygen, consistent with past years.

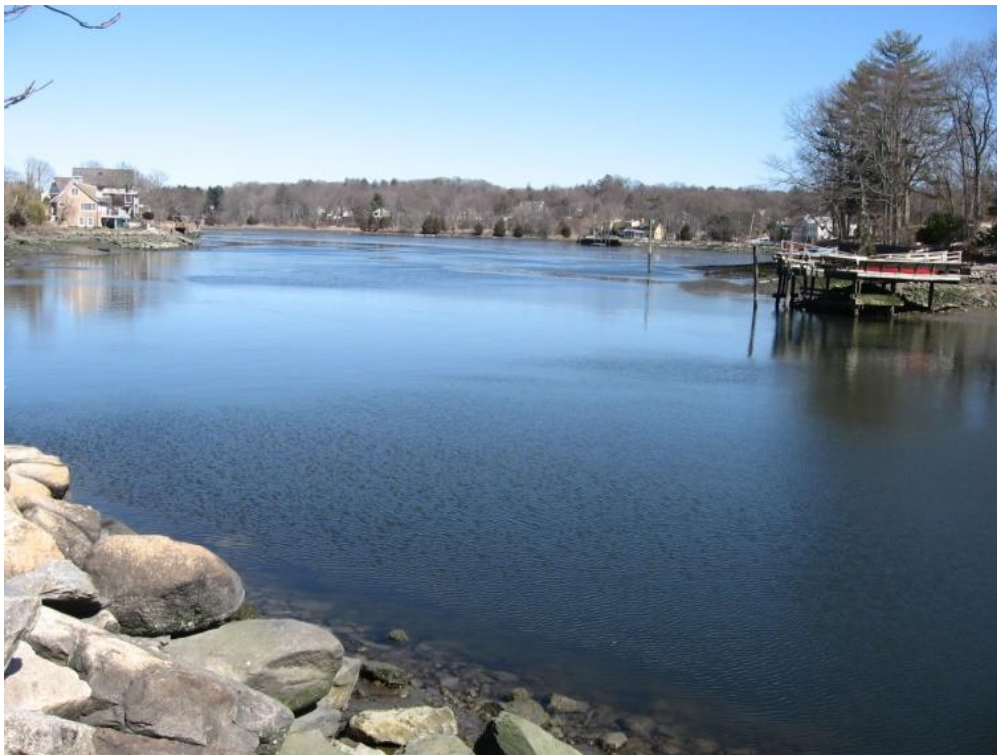
Figure 2.D.1. Looking upstream at the first basin from Saugatuck Harbor 6.

Situated at the mouth of the Saugatuck River, Saugatuck Harbor is approximately three miles long and relatively narrow with the exception of two basins. The first of these is a large basin located just to the north of station Saugatuck Harbor 6 (Figure 2.D.1, Figure 2.D.2). The second smaller basin is located just to the north of station Saugatuck Harbor 4 (Figure 2.D.2). The combined effect of these basins on ebb tide provides a strong flushing current for the estuary. The estuary then broadens into a wide but shallow harbor just to the south of station Saugatuck Harbor 3 (Figure 2.D.2). The land area on both sides of the upper estuary and the main harbor is mostly developed. The commercial area of the Town of Westport borders the northeastern side of the harbor above the Route 1 bridge. From this point moving southward the east bank of the harbor is residential up to the Longshore Country Club area and the Compo Boat Basin Marina. The west bank of the harbor is developed with a mixture of commercial businesses including a rowing club and a few small marinas. The Saugatuck Shores area on the western bank of Saugatuck Harbor is developed with single-family homes and two yacht clubs. Some salt marshes are present along the harbor margins south of the Canal Street bridge and just to the north of the I-95 bridge. Much of the shoreline has been filled for development but several large strip marshes are also still present along the western bank as the harbor opens into a larger basin near the mouth (Figure 2.D.2).

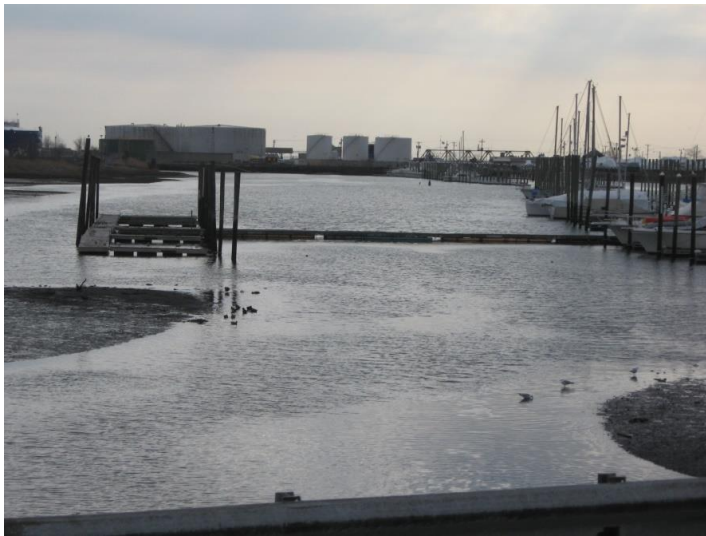
Figure 2.E.2. Looking down Johnsons Creek, which has many commercial land uses on its borders. The swing bridge in the background is where Johnsons Creek meets Lewis Gut.

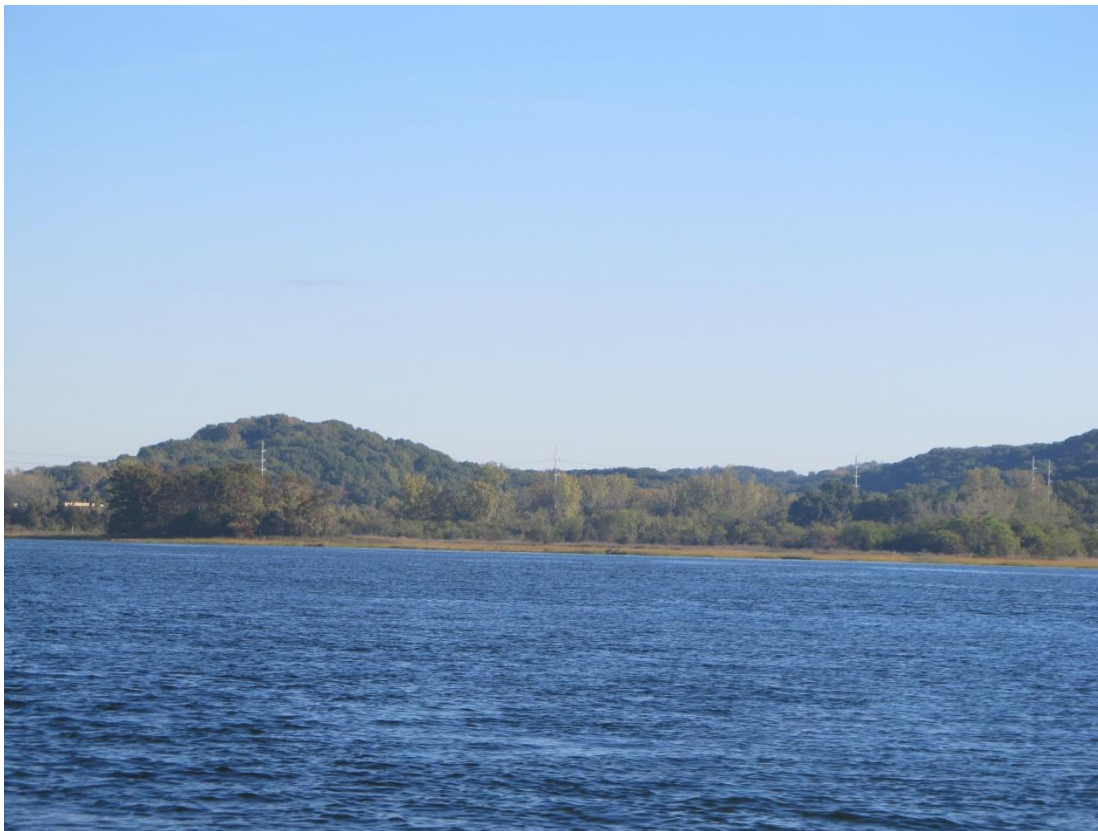
Figure 2.G.1. View of the large flushing basin in New Haven Harbor with extensive wetlands on the eastern shore.
